**LANDSLIDES OF TORREY PINES****2020**

David A. Bainbridge

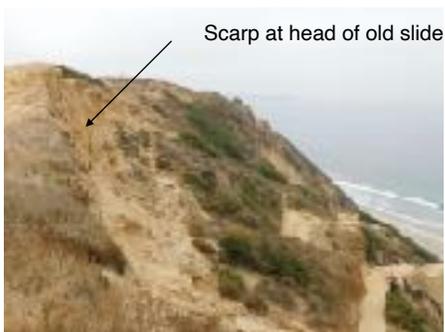
Glider port trail goes down old slide

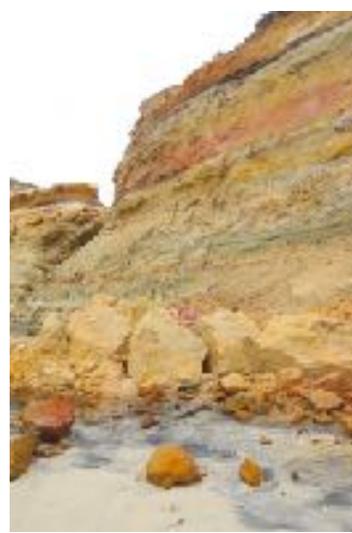
Canyon south slide  
Dec 2016

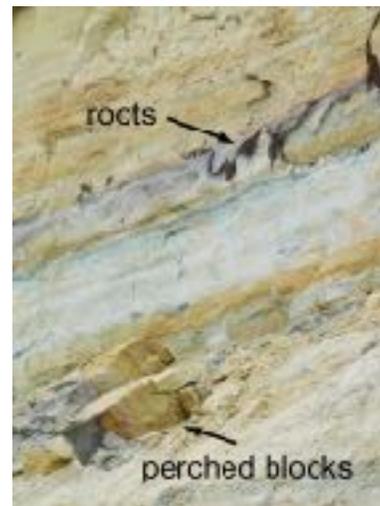
Arch slide blocks, roots at 100 feet behind the slab that fell

Water from irrigation and urban runoff can also make cliff failures more likely. If you see brush growing along a seam in the cliff face it is a sign of moisture in the formation. Pine roots followed the damp cracks down as far as 100 feet on the arch slide site. As roots grow they can force the cracks open, allowing more water to move into the crack, increasing root growth and making a landslide more likely.

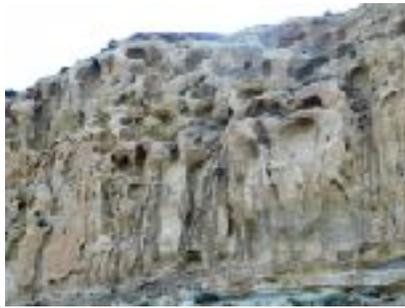
Highly weathered rough face likely to fail sooner

A smooth face with a debris pile is usually a sign that the cliff is more likely to be stable in this area, while a pocketed or rough cliff suggests it has been many years since the last slide and that it may be more risky. An arch feature can also be a sign of instability. Areas with obvious cracks, perched rocks and overhangs should simply be avoided. We watched a large boulder, “the rock of

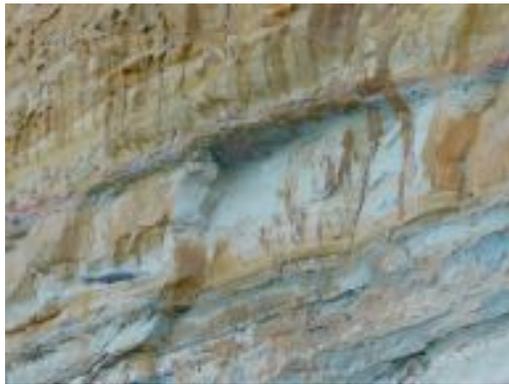
Smooth face after recent fall (2016). More likely to be stable—but no guarantee

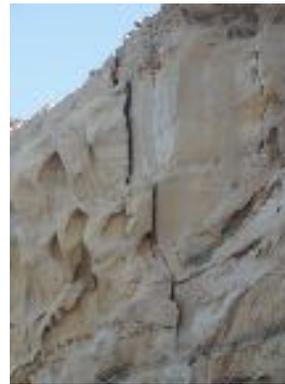
Overhang from recent rock fall, flake to left will go soon - then the cliff face above

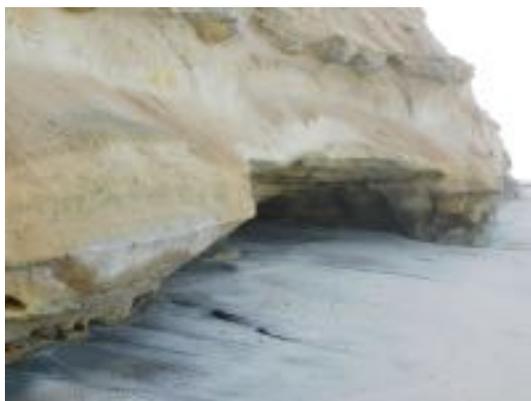
Torrey Pines Crack 2014 -this flake fell the following year
